Talisman Plantation: Living Shoreline Restoration & Protection of Hoghole Creek

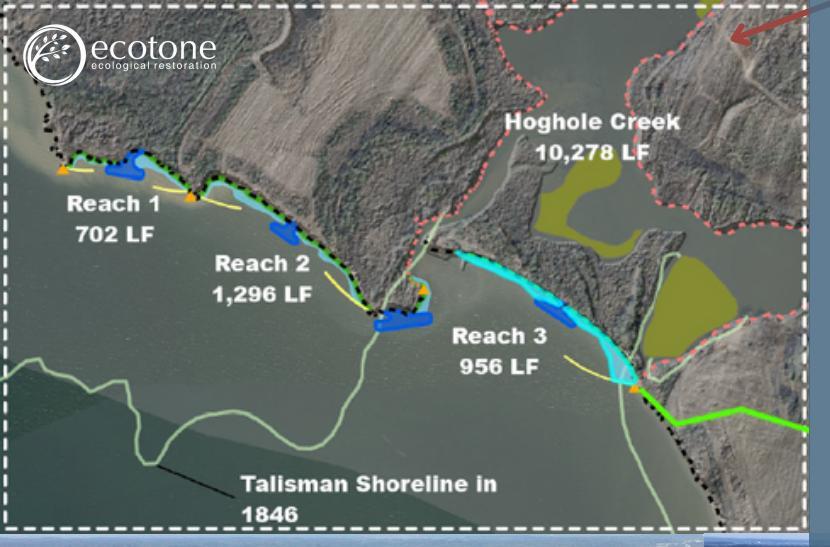
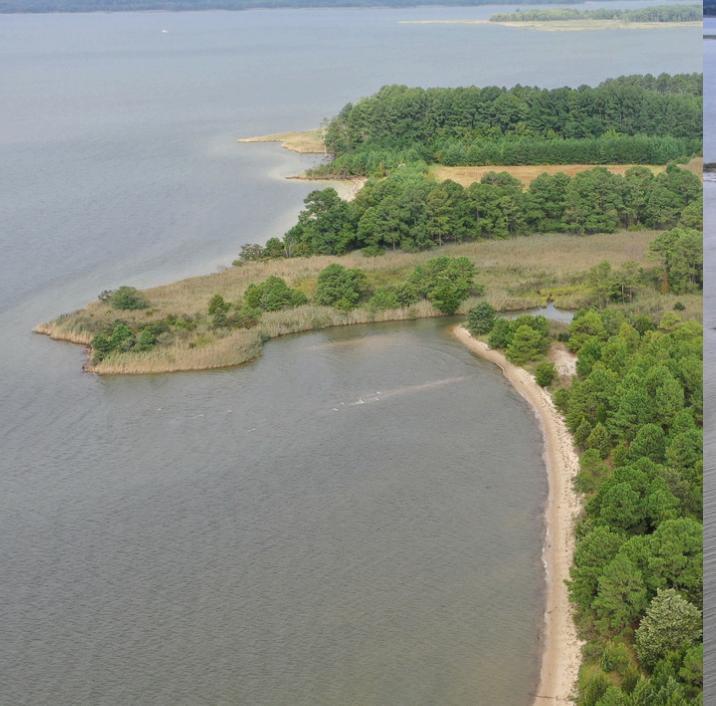
Below shows an original concept plan developed by Ecotone for addressing the shoreline erosion. In addition to creating rock sills to break incoming wave energy, the plan includes enhancement of existing habitats through treatment of invasive *Phragmites australis* and plantings of native trees and shrubs.
